FORM B - BUILDING

MASSACHUSETTS HISTORICAL COMMISSION  
Office of the Secretary, State House, Boston

In Area no.	Form no.
	23D-50

Address 89 Riverside Drive

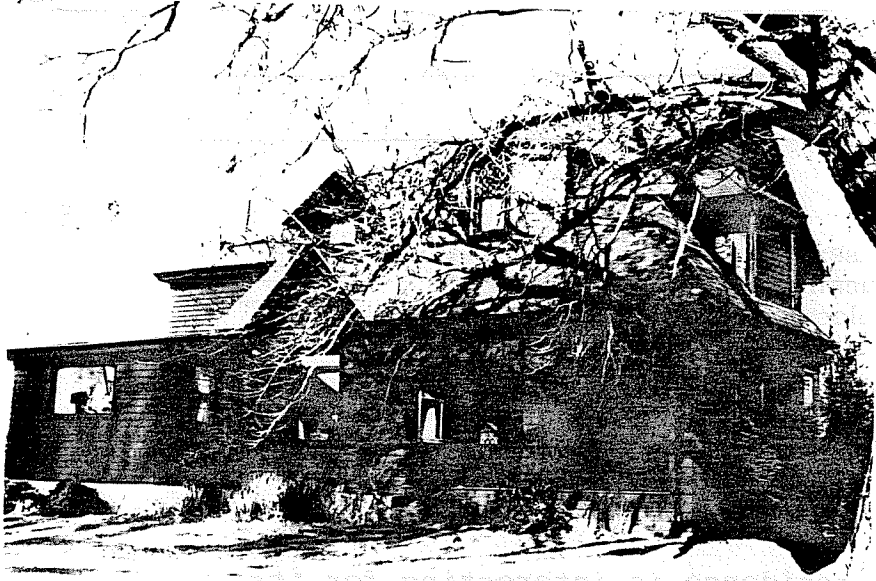
Exterior wall fabric wood shingles

This early 20th century residence is interesting for its complex massing and shingled surface. The porch which extends across the facade and halfway along the western side has broadly arched openings between the shingled posts, and is recessed under the extended gable roof. A bay dormer with polygonal roof is also on the western side.
