FORM B - BUILDING

MASSACHUSETTS HISTORICAL COMMISSION
Office of the Secretary, State House, Boston

Address 57 Market St.

Name S. Strong II House

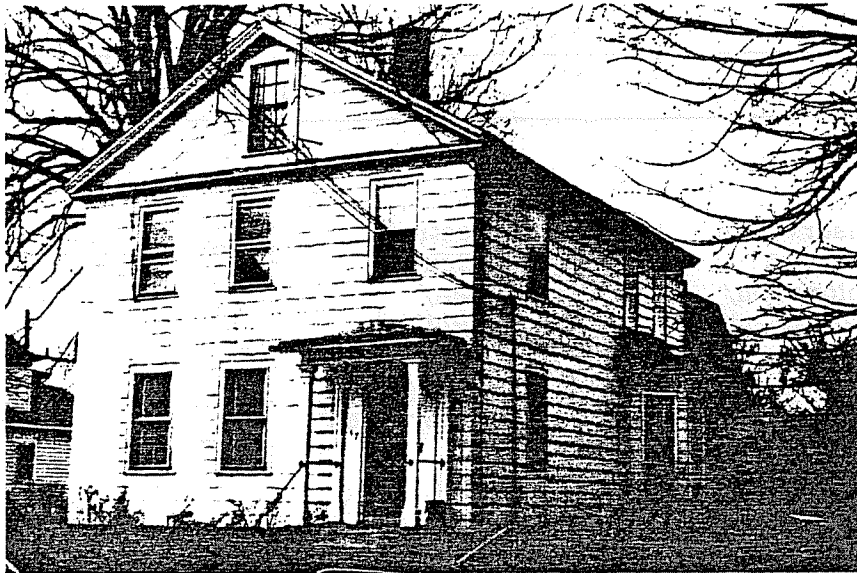
Exterior wall fabric asbestos shakes

Altered sided Date mid 20th c.

The house is 2 1/2 stories in height with pedimented end to the street. The asbestos siding has covered most detailing, but the basic form remains. There is a six over six sash window in the front pediment, and six over six windows are also used on the second floor. The three-bay facade has a side entrance which is covered by a one-story, hipped roof porch with paneled posts, and there is a one-story bay window on the southern side of the house.
