In Area no.	Form no.
	32C-226

1 Northampton
 Address 67 Hawley St.
 Name
 Present use residence
 Present owner Antonia Zimnoch
 Description:
c. 1870
 Source Atlas and Directory

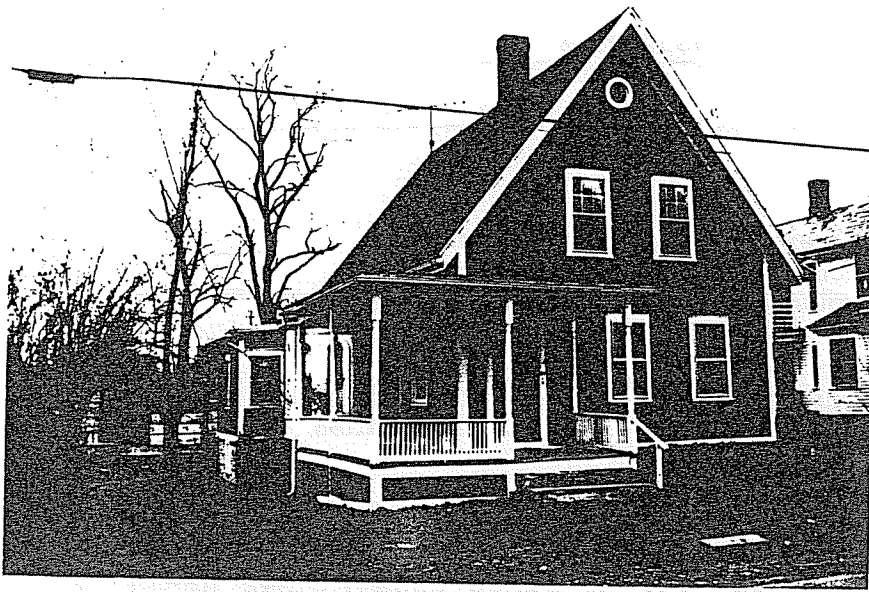
This house was probably built during the 1860's and features a steeply-pitched gable with an oculus in the apex. The windows have plain surrounds and six over six sashes. A one-story entry porch wraps around the southern side to the projecting bay window, and is composed of turned posts, a balustrade and lattice base.
