# OLD-HOUSE JOURNAL

JULY • AUGUST 1994

# POKING INTO THE PAST

*Is your old house  
hiding its historic  
details? An  
investigator  
explains how he  
uncovered a home's  
previous lives.*

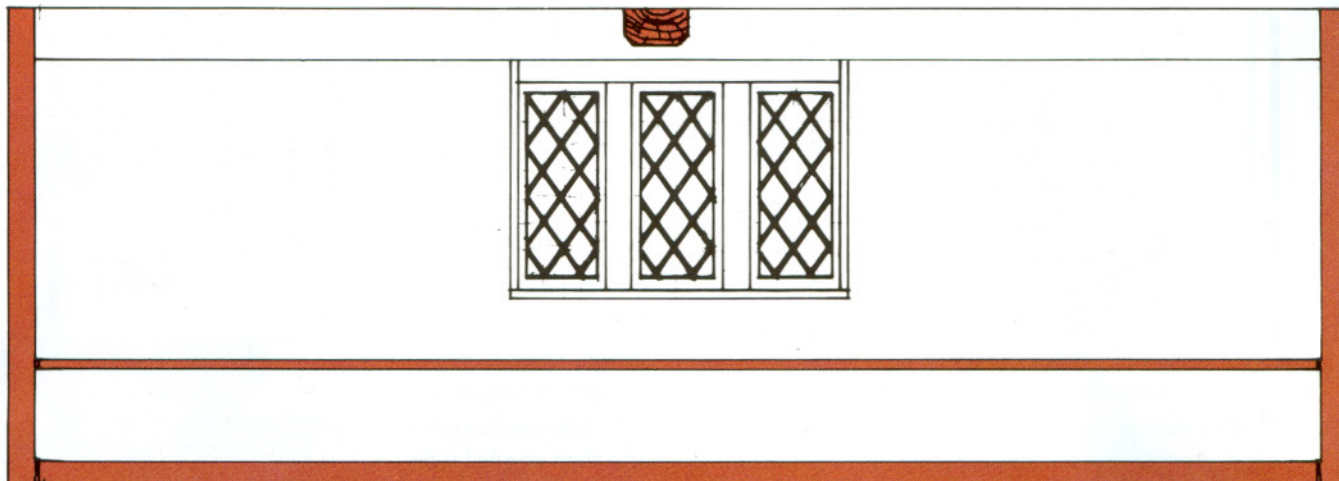
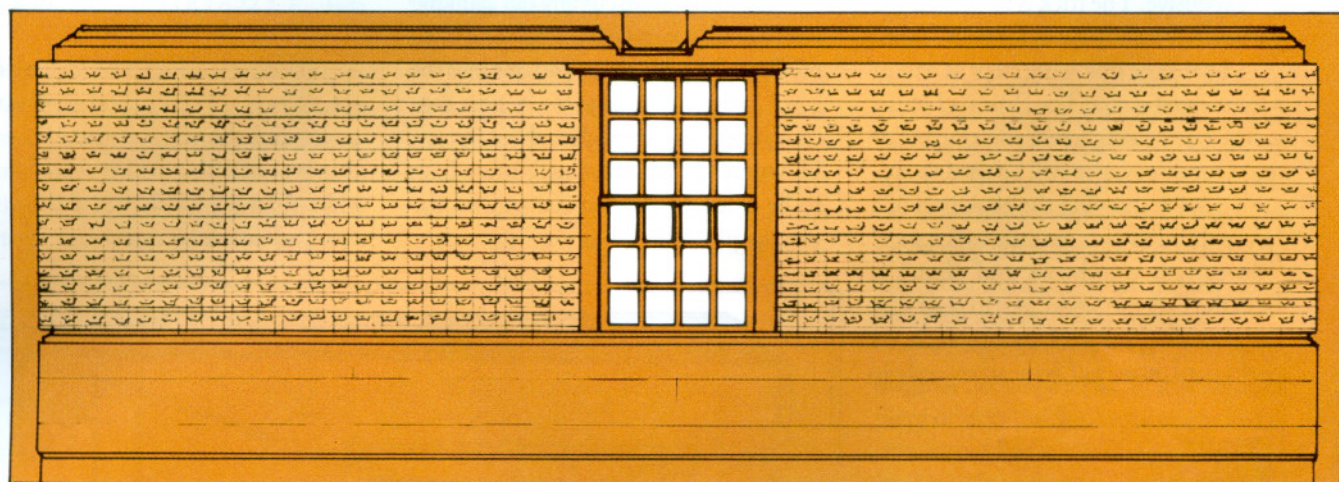
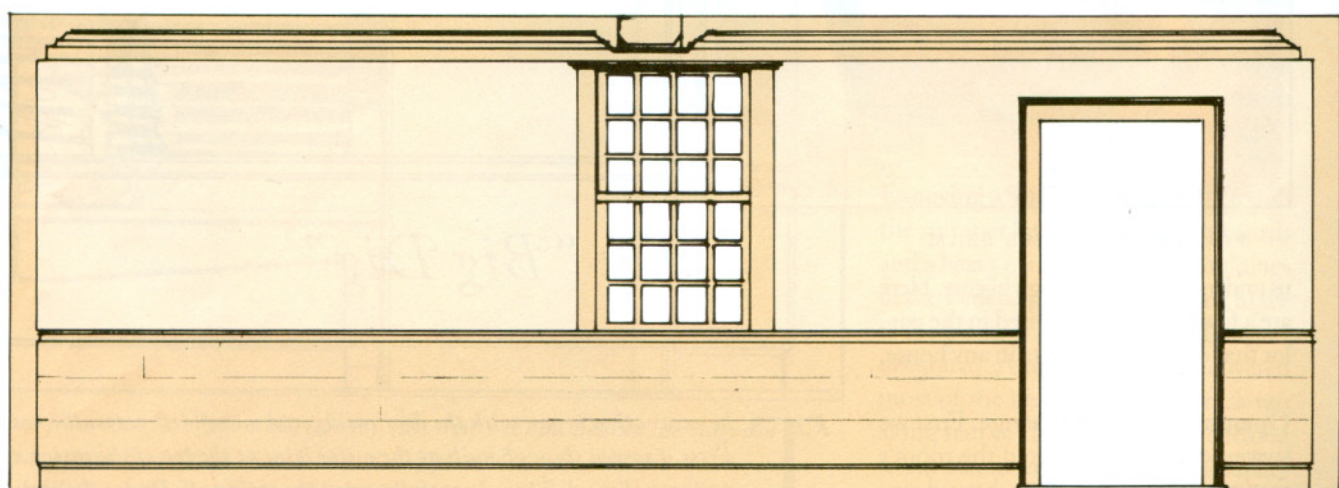
*We uncovered three incarnations of a parlor wall. Originally, white plaster was only broken by a narrow chair rail (top). In the early 1800s, the window was reduced, complex cornice moulding, wood wainscot, and wallpaper were added, and the summer beam was encased (middle). Today, the Federal casings remain, yet a door has been added and the wallpaper removed (bottom).*

C. 1730

EARLY 1800S

C. 1991

The original c. 1730 finish scheme included large window openings, exposed timber framing, a narrow chair rail and simple baseboard on plain plaster walls. We suspect none of the woodwork had been painted. By the late 1700s or early 1800s the room had been completely remodeled with new, fancier Federal woodwork, and decorated with wallpaper and a few coats of paint. By the 1900s, new doors had been added, wallpapers were removed, and more coats of paint had been applied.

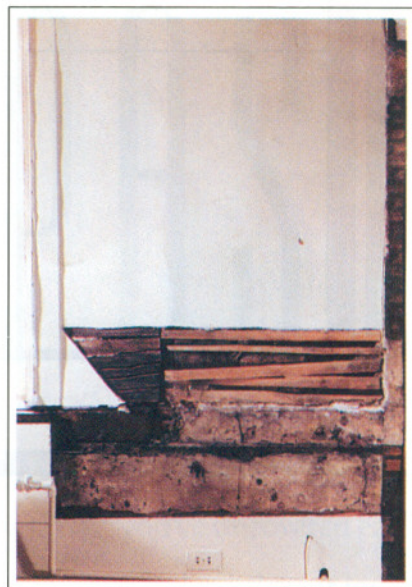
FIG. 3 EXCAVATING THE PLASTER

With the casing removed, we could see a fragment of Federal-period wallpaper and the edge of the plaster and thin wood lath — which seemed much older than the finish. So, we expanded the excavation by removing plaster to

the left of the door, and found thin, irregular riven lath (split directly from the log) and gray plaster with grass as a reinforcement fiber. This archaic type of plastering system was common early in the 18th century and was probably

*removed from the rest of the wall, leaving this strip behind. Behind the ridges in the wall was a transition from riven lath and clay plaster to split lath and white plaster (Fig. 3). We determined that the transitions represent where the original window had been. The fancy chamfer on the summer beam (Fig. 4) told us it had originally been exposed.*

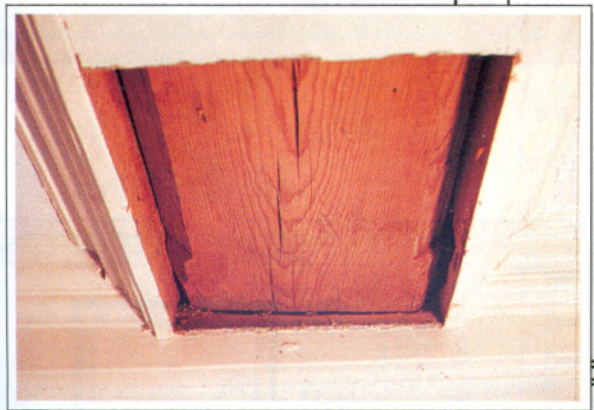
FIG. 4 THE SUMMER BEAM

With a piece of the board removed, we could see the summer beam itself was unpainted and had chamfered edges with a fancy stop. Clearly this beam was originally meant to be left exposed, otherwise it would not have been decorated with the chamfer. We began to build a picture in our minds of how this room looked underneath the outer layer of Federal decoration: very plain with simple unpainted woodwork.

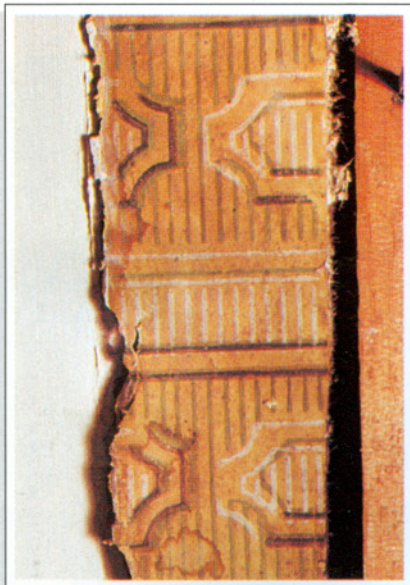
FIG. 2 LATE FEDERAL WALLPAPER

**T**he excavation began with the door casing and moved left across the wall. First, I sawed through nails at the miter joint at the top of the casing with a pad saw (Fig. 1). Then, I carefully pried the casing off. Under the casing, we found late-Federal wallpaper (Fig. 2), which had been applied in horizontal strips sometime before the door to the room addition was cut through. Later, the paper was

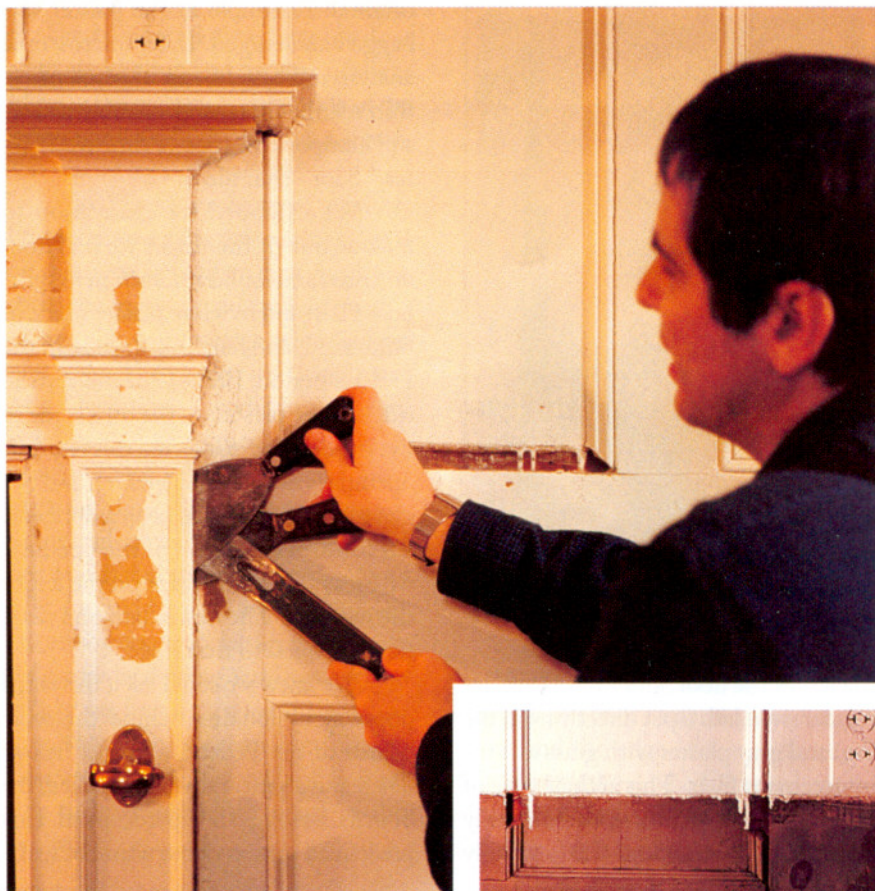
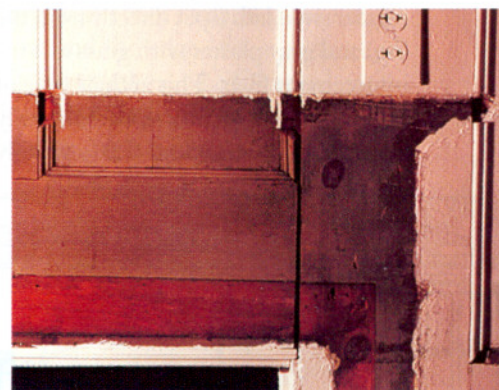
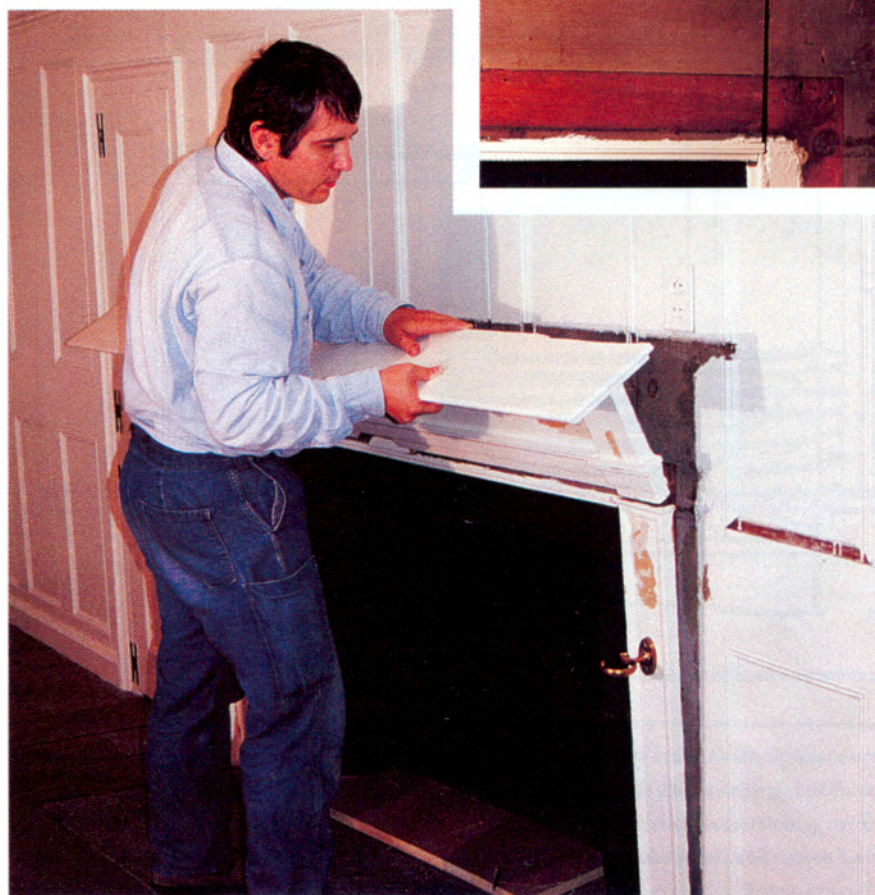
*Loosening the mantel required the wiggle and wedge technique (top). The mantel is made up of sections, which need to be carefully handled to prevent damage (bottom). An earlier fireplace surround moulding left its shadow in the paint (inset).*

I removed the mantel using the wiggle and wedge technique. Once all of the woodwork was loose I carefully pulled off the pilasters, lintel, and mantel shelf. Beneath the mantel were two coats of paint. The first was a deep blue. The top coat was a much lighter blue-green. A ghost through both of these layers indicated a  $2\frac{3}{4}$ " wide moulding had once surrounded the fireplace. Square nail holes were a clue it had been attached with hand-wrought nails. This was probably a bolection moulding that had been removed when the current mantel was installed sometime before 1825. It provided clear-cut evidence of an early-Federal fireplace surround. We suspected it was very simple, without a shelf. We looked but found no evidence of what had been here originally.

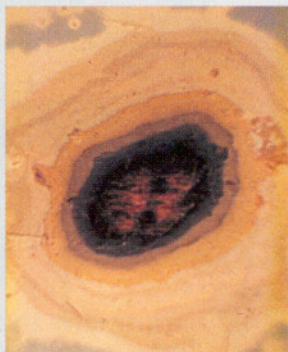
Cratering, a basic field method of investigating paint chronology and colors, can reveal even more.

1. Rub an area of painted moulding with sandpaper (220 grit is good) in a small circle. Create a shallow crater to reveal the layers of paint as rings of color visible to the naked eye.
2. Use successively finer grits (400 to 600) to polish the crater, showing the layers more distinctly.
3. Moisten the crater slightly with water or mineral spirits. They act as a sanding lubricant, help control the hazard of lead paint dust, and make the colors of the layers clearer.
4. Make craters in each of the areas you're analyzing. When they clearly display the paint layers, compare how the layers of paint differ from one element of the building to another.
