FORM B - BUILDING

In Area no.	Form no.
	25A-136

City Northampton

Address 1-7 Glenwood Avenue

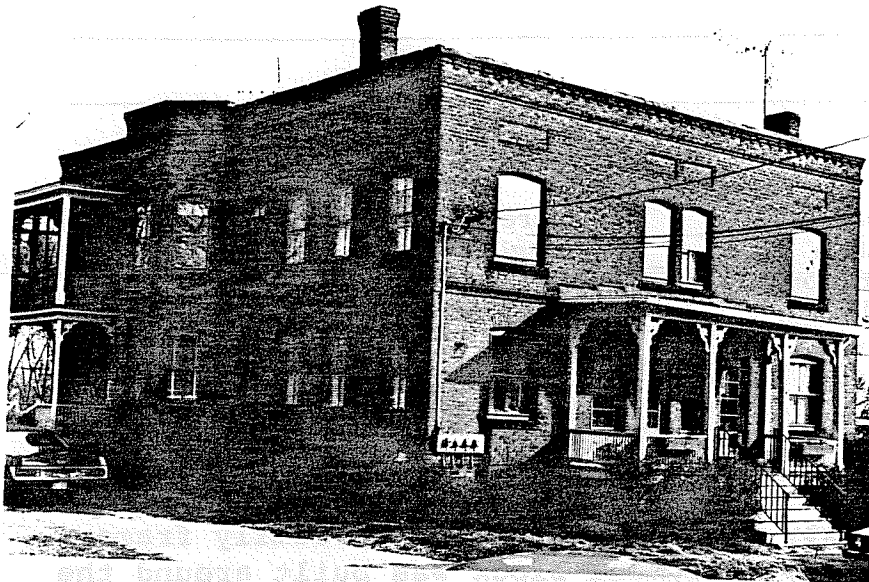
Exterior wall fabric brick

Other features brownstone sills, 1-story

front porch with decorative brackets  
brick watertable, string course and  
corbelled cornice

The block is notable for its decorative qualities, which are primarily executed in brick. These include a watertable, continuous string course between the first and second floor, recessed panels above the second floor windows, and a corbelled cornice with frieze. A 2-story, 3-sided bay is on the side of the block along with a 2-story porch. A one story porch with decorative brackets graces the front.
