FORM B - BUILDING

MASSACHUSETTS HISTORICAL COMMISSION
Office of the Secretary, State House, Boston

Address 57 Henshaw Ave.

Name M. and E. Bliss House

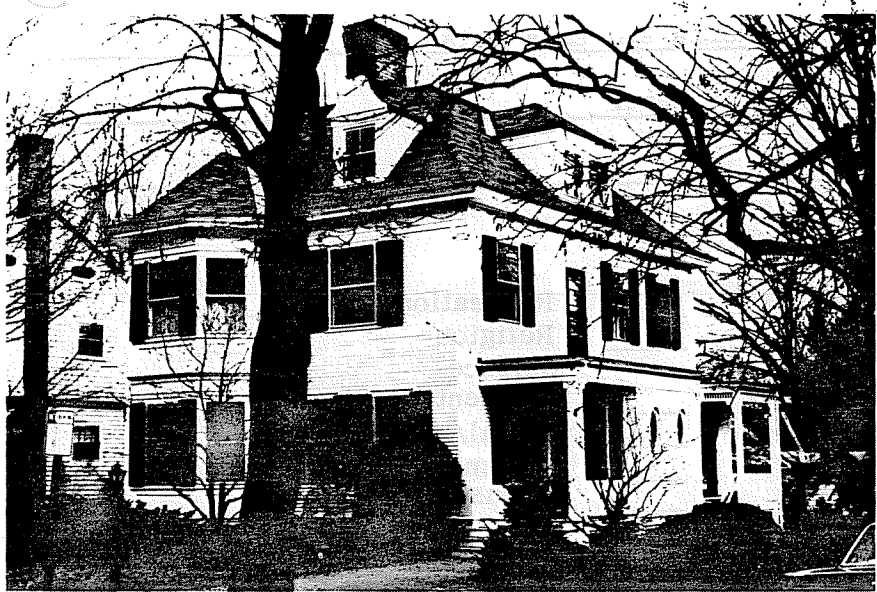
Other features pluted Ionic corner pilasters, festooned frieze, 2-story bay with polygonal roof, side porches.

The house is two stories in height with hipped roof. A festooned frieze encircles the house beneath the cornice and fluted Ionic pilasters are used at the corners. The Henshaw Ave. face of the house features a two-story bay window with polygonal roof and decorated panels, while the main entrance is located on the southern side. The entrance, with sidelights and Ionic pilasters, faces front from a one-story projection and is covered by a porch with flat roof and fluted Ionic posts.
